Manhole Inspection Summary

Manhole # S11YY1011MH

Insp Date: **7/18/06 10:19 AM**

Location Address: **5602 EVERTON RD** Cross Street: **ROCKSPRING RD**

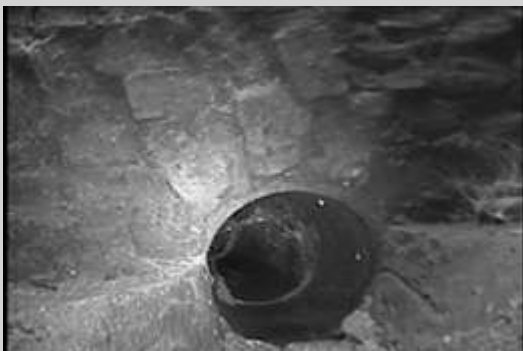
8 in. Circular Gravity Sewer Pipe In @ 3 O'Clock

Pipe Material: **Clay** ☐ Pipe Lined

Invert Depth: **9.39** (ft.) Flow Characteristics: **None**

Deposits: ☒ None ☐ Mud ☐ Sludge ☐ Debris ☐ Grease

Infiltration: **None** Pipe Seal Cond: **Unknown**

Connects To: **Dead End**

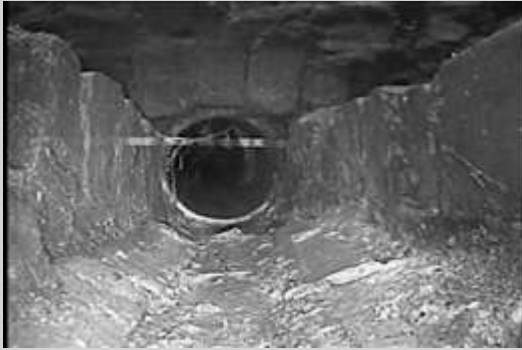
6 in. Circular Gravity Sewer

Pipe Material: **Clay** ☐ Pipe Lined

Infiltration: **None**
